LB7 INJECTOR LINE CORROSION

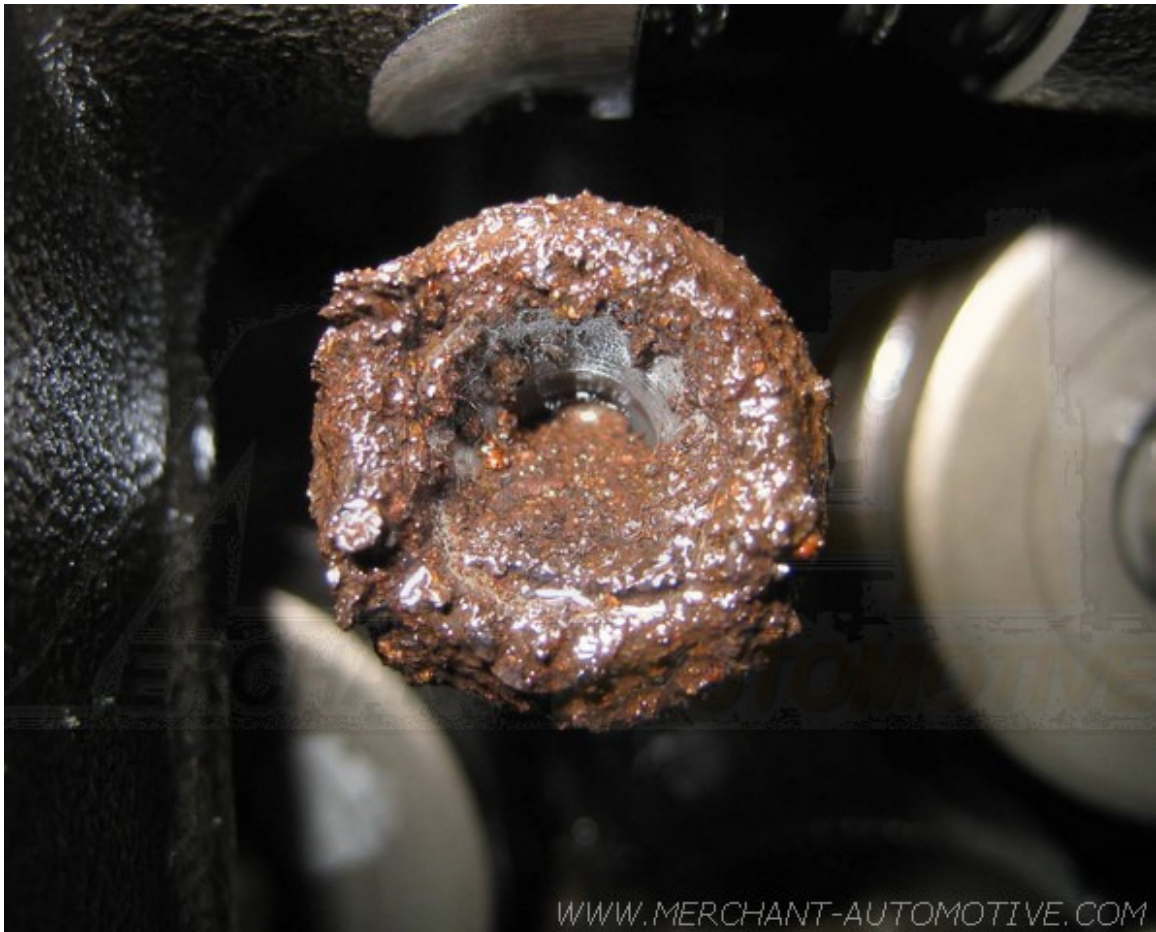
If you have ever worked on a LB7 Duramax engine, this may not be the first time you have seen the inlet of an injector that looked like that. A lot will ask themselves where this debris and rust comes from and how did it get past the fuel filter? What kind of damage did that do to my injectors? How do I clean my fuel system if there is that much rust in it?

Well, the good news is that it did NOT come out of your fuel system. It's not in your tank, past your filter or anyplace that needs to be concerned with. The buildup is something that found its way into the injector inlet during line removal. Let's first see where this comes from.

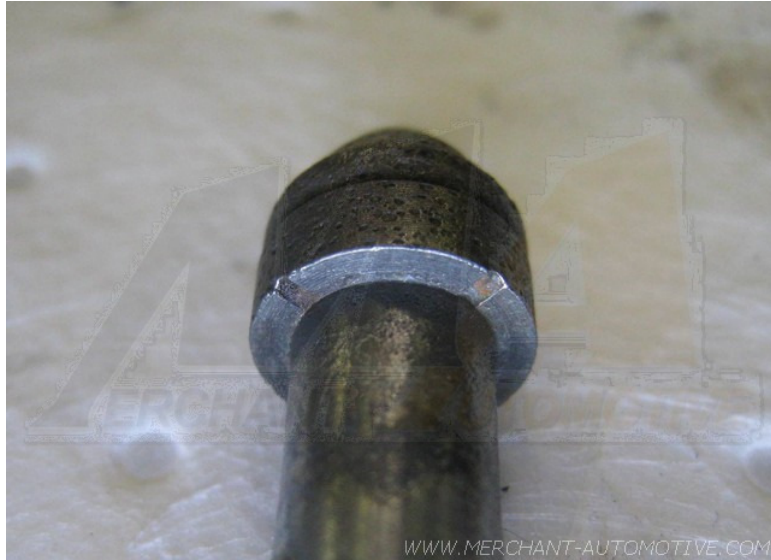
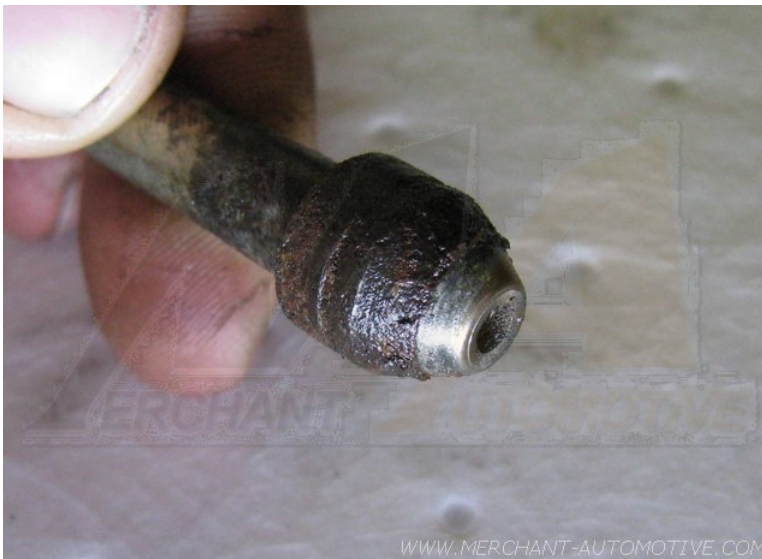
When Duramax engineers were designing the LB7 fuel system, one concern they had was that since the injectors were completely under the valve covers, how would they deal with a leak should it develop at the high pressure fitting? This fitting is under the valve cover and would leak diesel fuel into the crankcase if it was to leak. To prevent contamination, they added a small o-ring at the base of the threads to seal to the line. If the fitting should leak, the o-ring would keep the fuel out of the crankcase. A series of small grooves was then put in the end of the line under the nut. The nut would push down on the line forcing the seal at the injector. You can see the small grooves in the backside of the fitting. These small grooves would allow any fuel leaked to get past the nut and out side of the engine. The downside to this is that it also would allow water and debris down to around the fitting. Over time, contamination would collect. This is evident by the amount of rust and pitting on the line.

You can see the amount of rust right up to the very tip of the fitting. What is very important to note is that the tip of the line is still relatively clean and free of any rust or damage. This is the point where the line actually seals to the injector body.

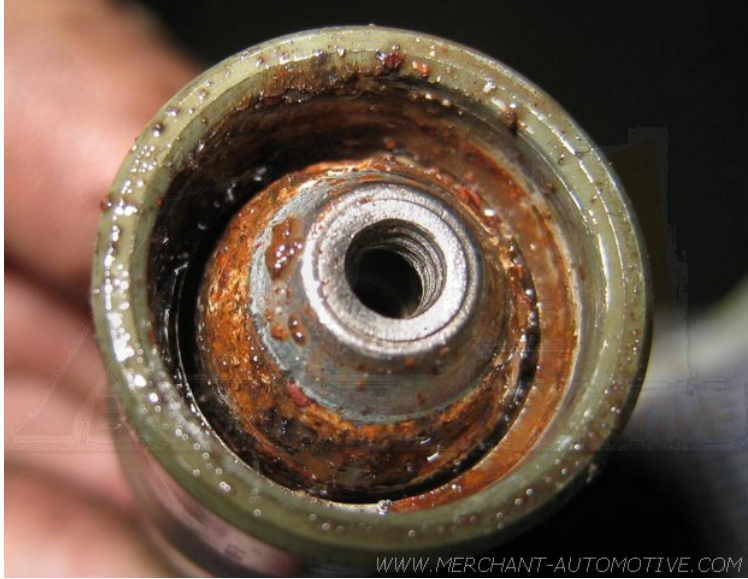
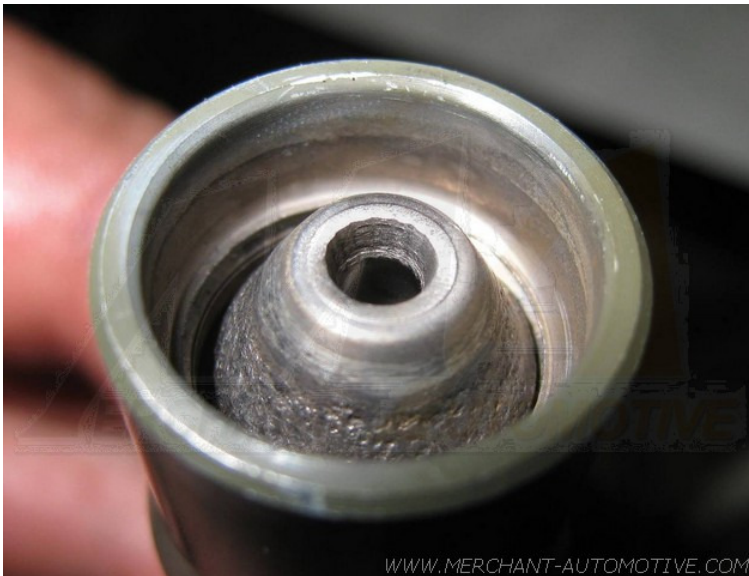
Here is an actual line removed from an engine in for service. You can see again the amount of rust and corrosion present in side the line, but the tip is still clean and rust free. This line is still completely usable after a cleaning process. We need to make sure to remove all of the loose rust and thoroughly clean the inside of the line so that it will make a proper seal again. Below is this same line after it has undergone the cleaning process. Perfectly good and ready to reinstall.

All of the rust and corrosion is removed. The sealing area of the line at the bottom of the taper is in good condition.

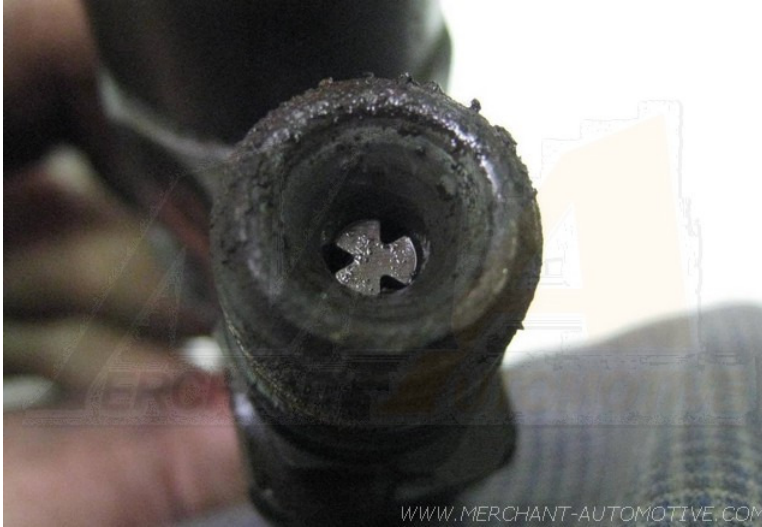
This is what the injector should look like as you keep tapping it upside down. There is still more clean up needed on this one, but you get the idea. Once you have the inlet as clean as it will get, I like to take a bit of alcohol or brake clean in a small container, a contact cleaning case works well, dip the injector inlet in the solution upside down and then continue tapping, this will help rinse out the

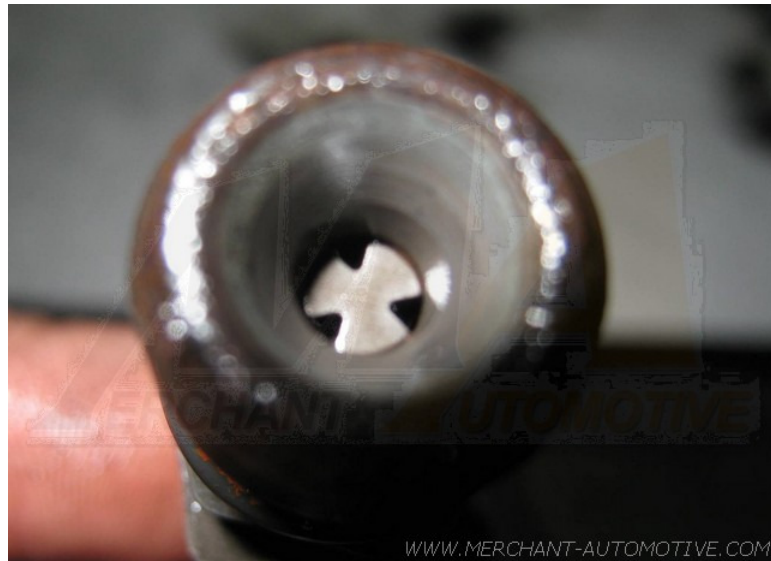
debris. Again, DON'T spray into the inlet. A bit of scotch brite will help clean up the threads from the rust. All of the loose rust and debris has been removed and the inlet is clean. No debris is visible in the edge filter at the bottom of the inlet either. This injector is ready to reinstall.
